Investigation of Deterioration of Joints in Concrete Pavements

National Concrete Pavement
Technology Center

Final Report
August 2012

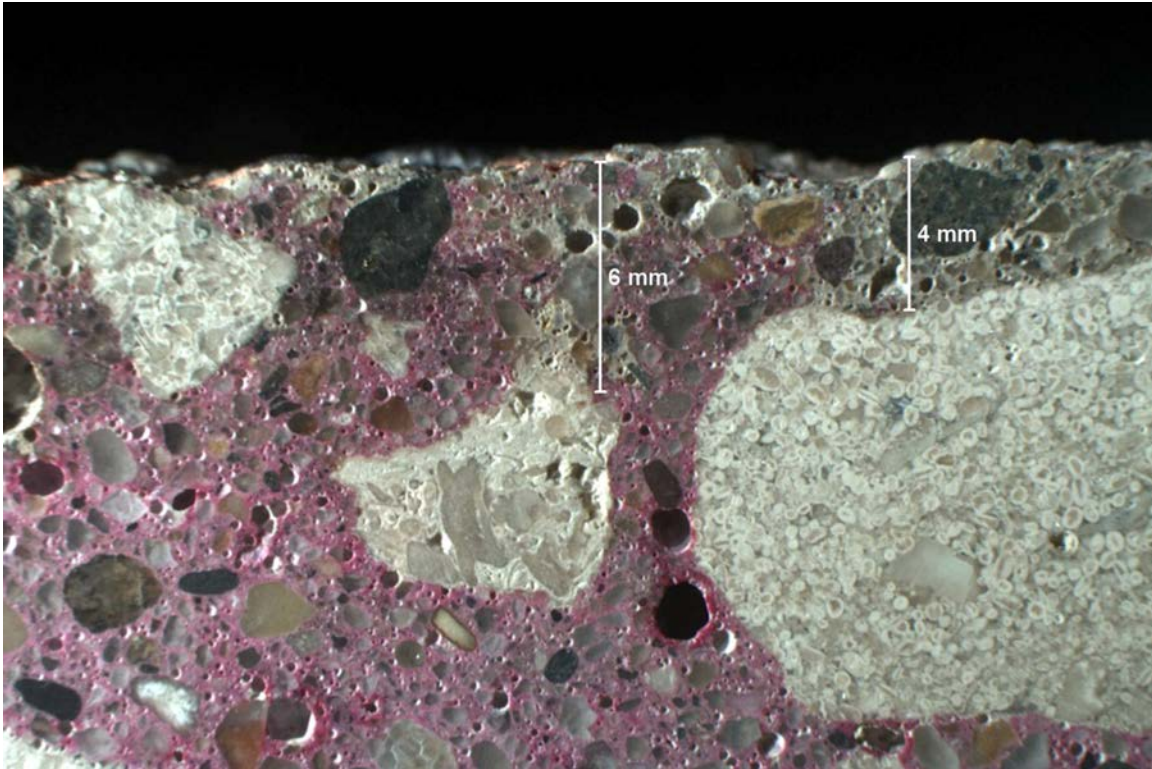
PHOTO: 8

SAMPLE ID: #1 **DESCRIPTION:** Carbonation (unstained paste) proceeds up to 6mm depth from the mortar eroded top surface of the core sample.
MAG: 5x

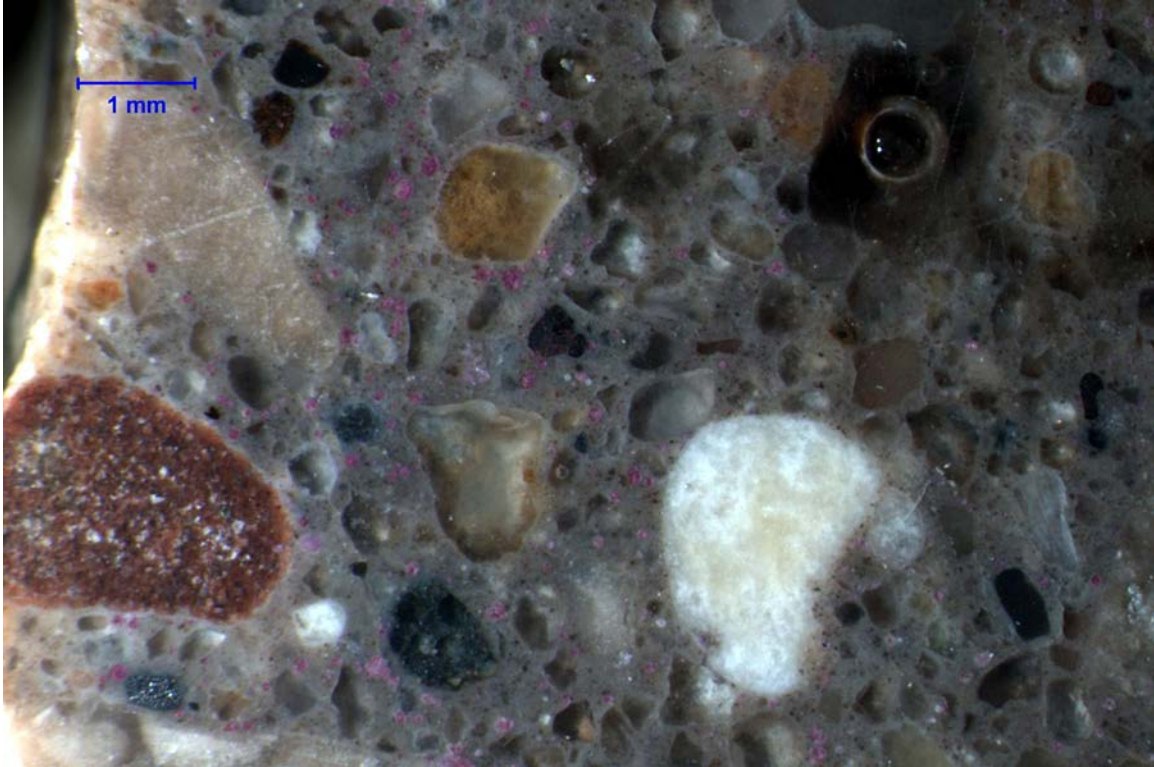
PHOTO: 12

SAMPLE ID: #1 **DESCRIPTION:** Much of the air voids proximate to the distressed joint plane are filled with secondary ettringite which has been stained a magenta coloration.
MAG: 15x

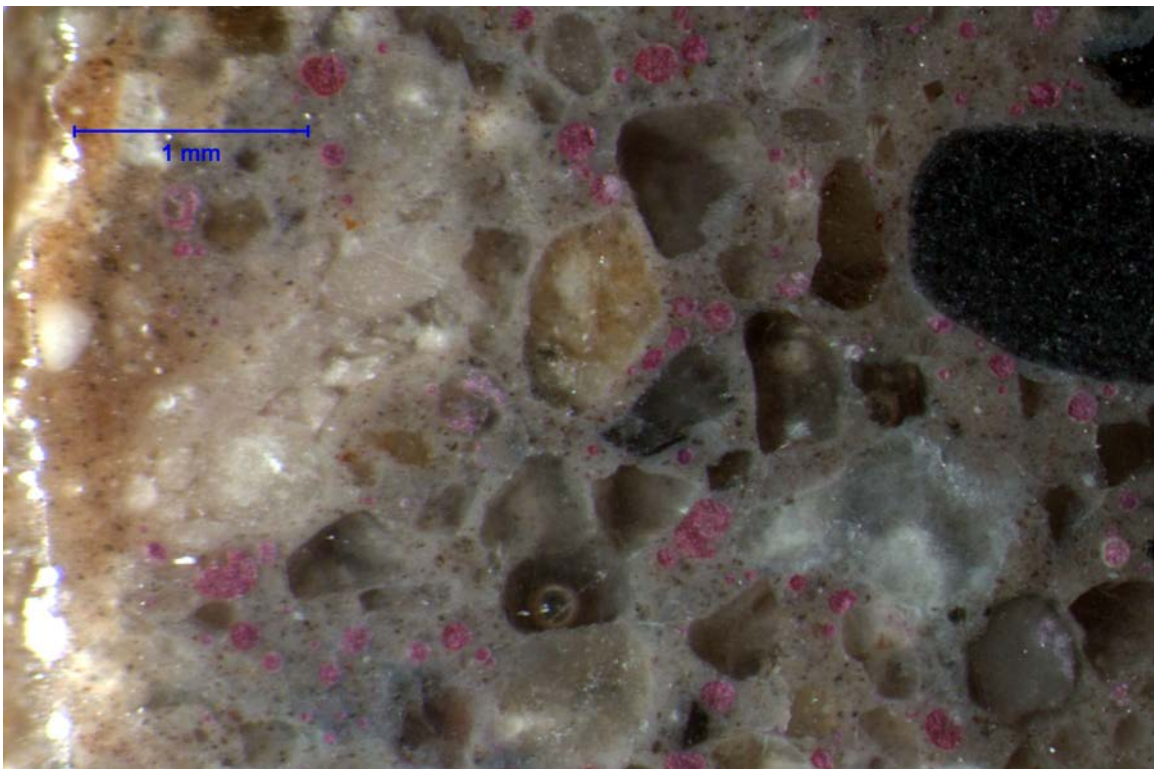
PHOTO: 13

SAMPLE ID: #1 **DESCRIPTION:** Much of the air voids proximate to the distressed joint plane are filled with secondary ettringite which has been stained a magenta coloration.
MAG: 30x

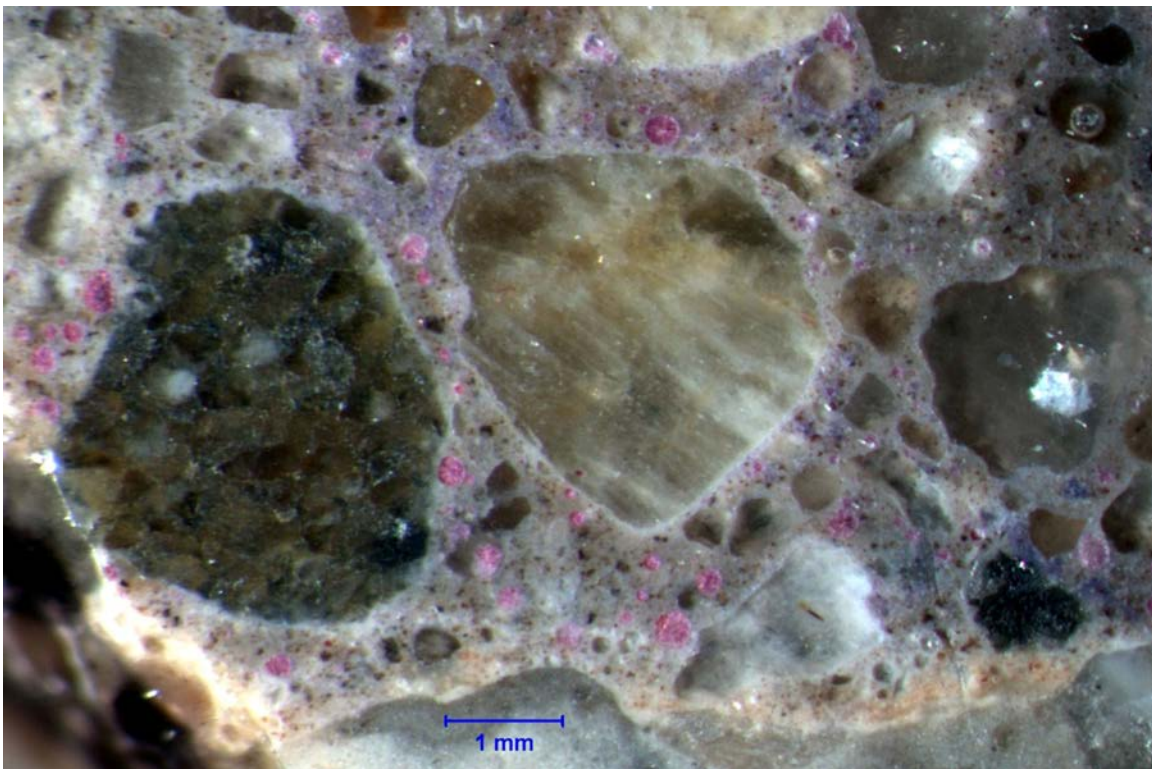
PHOTO: 23

SAMPLE ID: #2 **DESCRIPTION:** Much of the air voids proximate to the joint are filled with secondary ettringite; stained a magenta coloration.

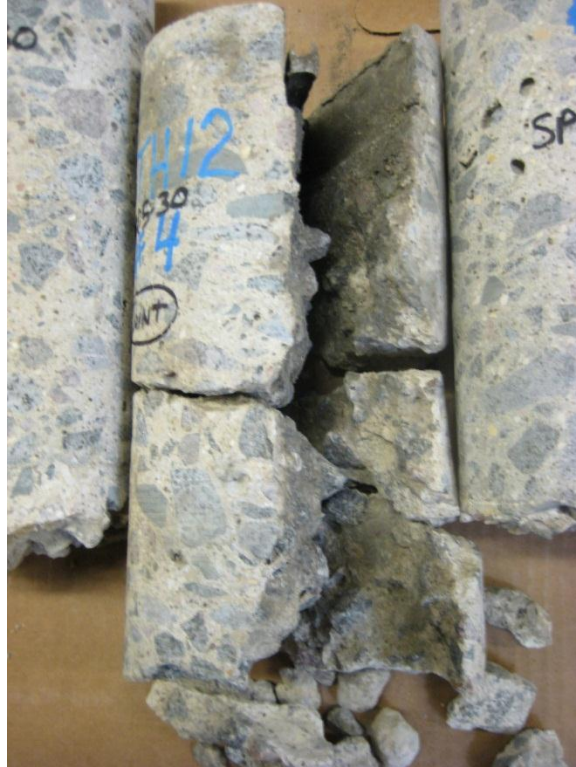
Figure 1. 4705-30 Core 4

Two cores were taken from Route 12 west of Minneapolis. One, labeled 4 (Figure 1), was selected as representing a distressed joint, while the other, labeled 7, appeared to be in better condition (Figure 2).

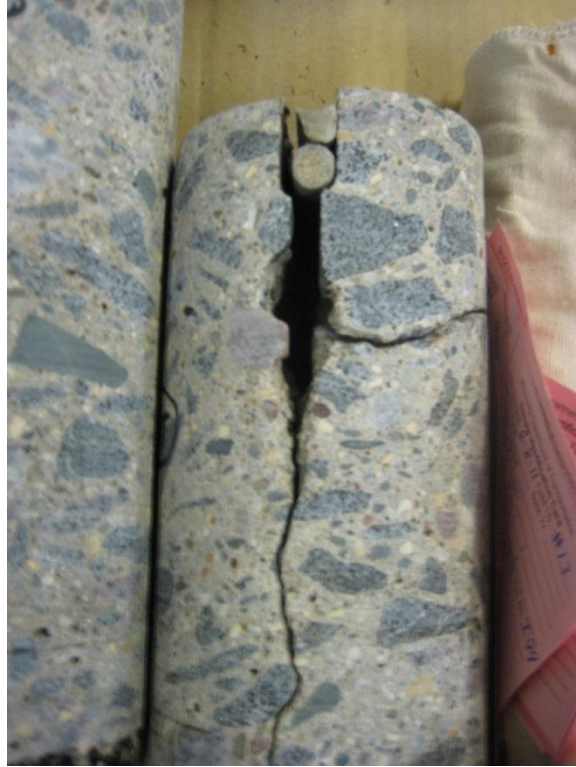
Figure 3. 7380 Core 7009

Two cores were taken from Route 94 near Brainerd. One, labeled 7009 (Figure 3), was selected as representing a distressed joint including a so-called tunnel at the bottom of the joint, while the other, labeled 7012, appeared to be in better condition (Figure 4).

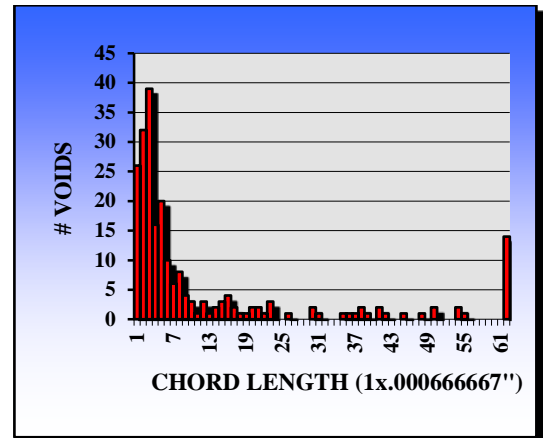
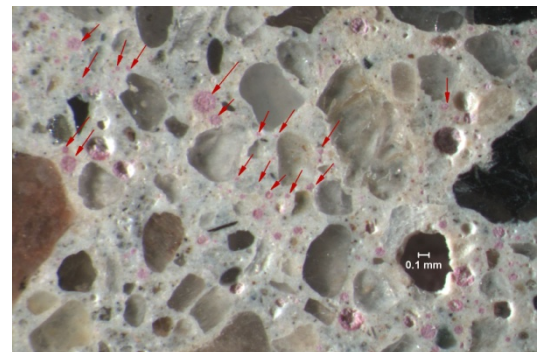
Magnification: 30x
 Description: Filled air void system 120mm from the top surface and 8mm from the joint crack.

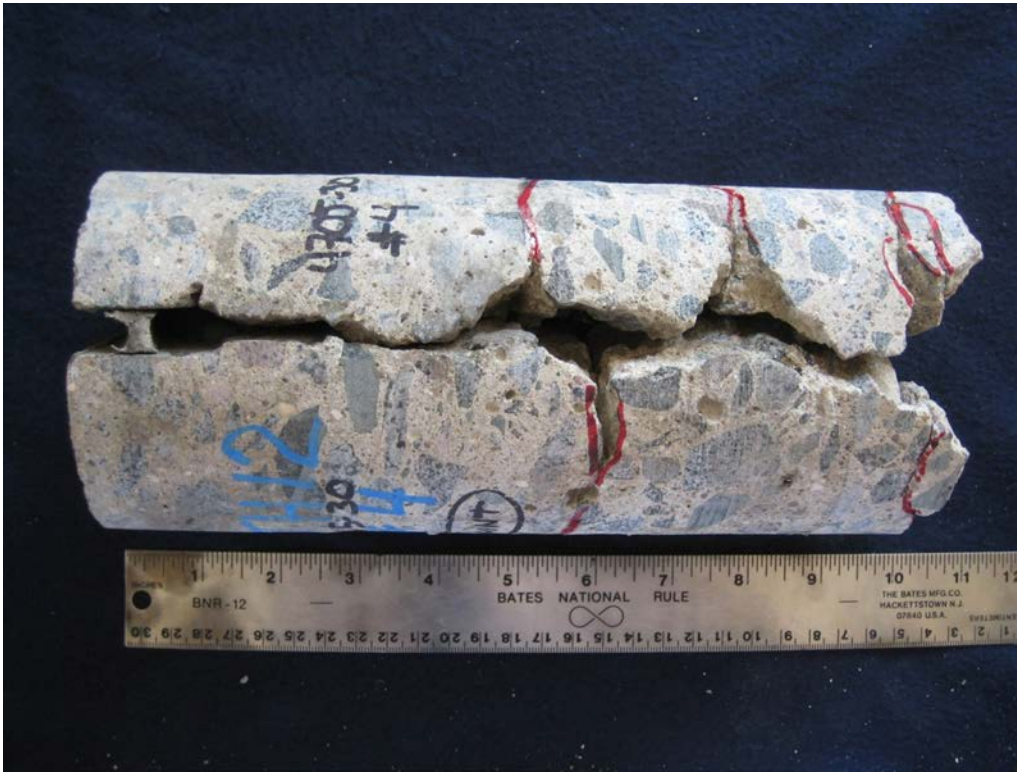
PHOTO: 1

SAMPLE ID: 4, 4705-30 **DESCRIPTION:** Core sample taken directly through a pavement joint, as received. Top surface is left. Existing fractures are mapped in red ink.

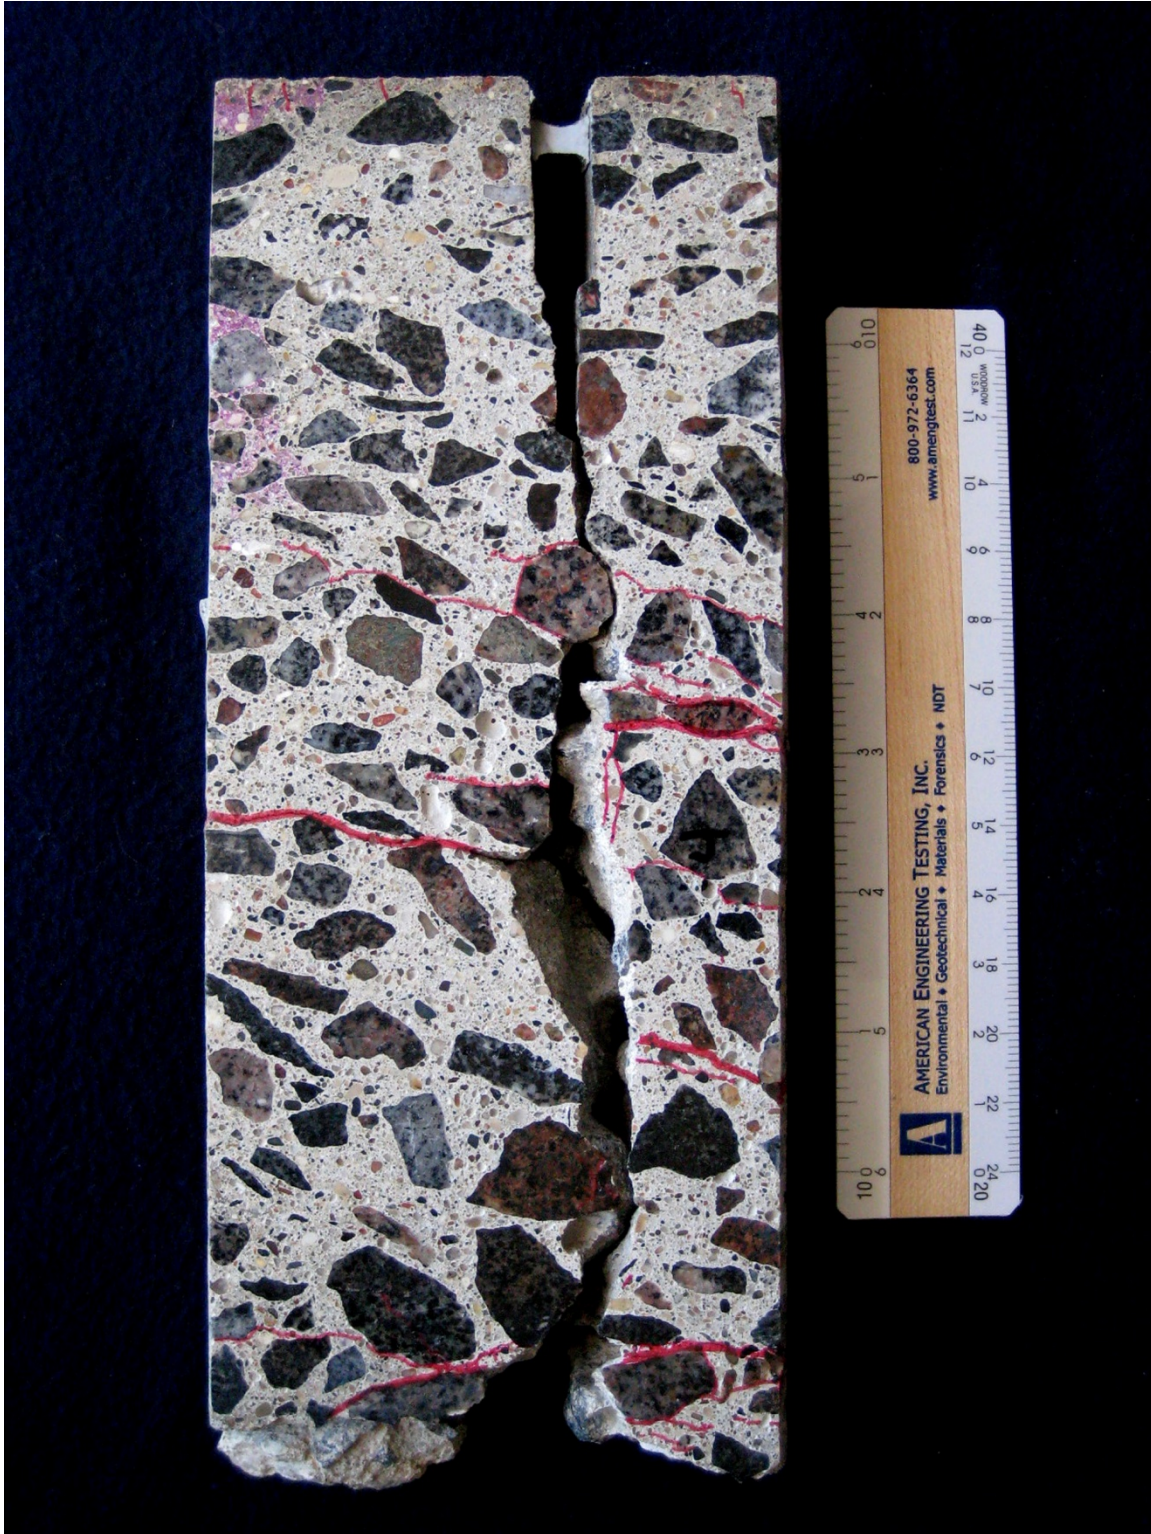
PHOTO: 9

SAMPLE ID: 4, 4705-30 **DESCRIPTION:** Sawcut and lapped cross section of core. Mostly sub-horizontally oriented fractures and microcracking are mapped in red ink.

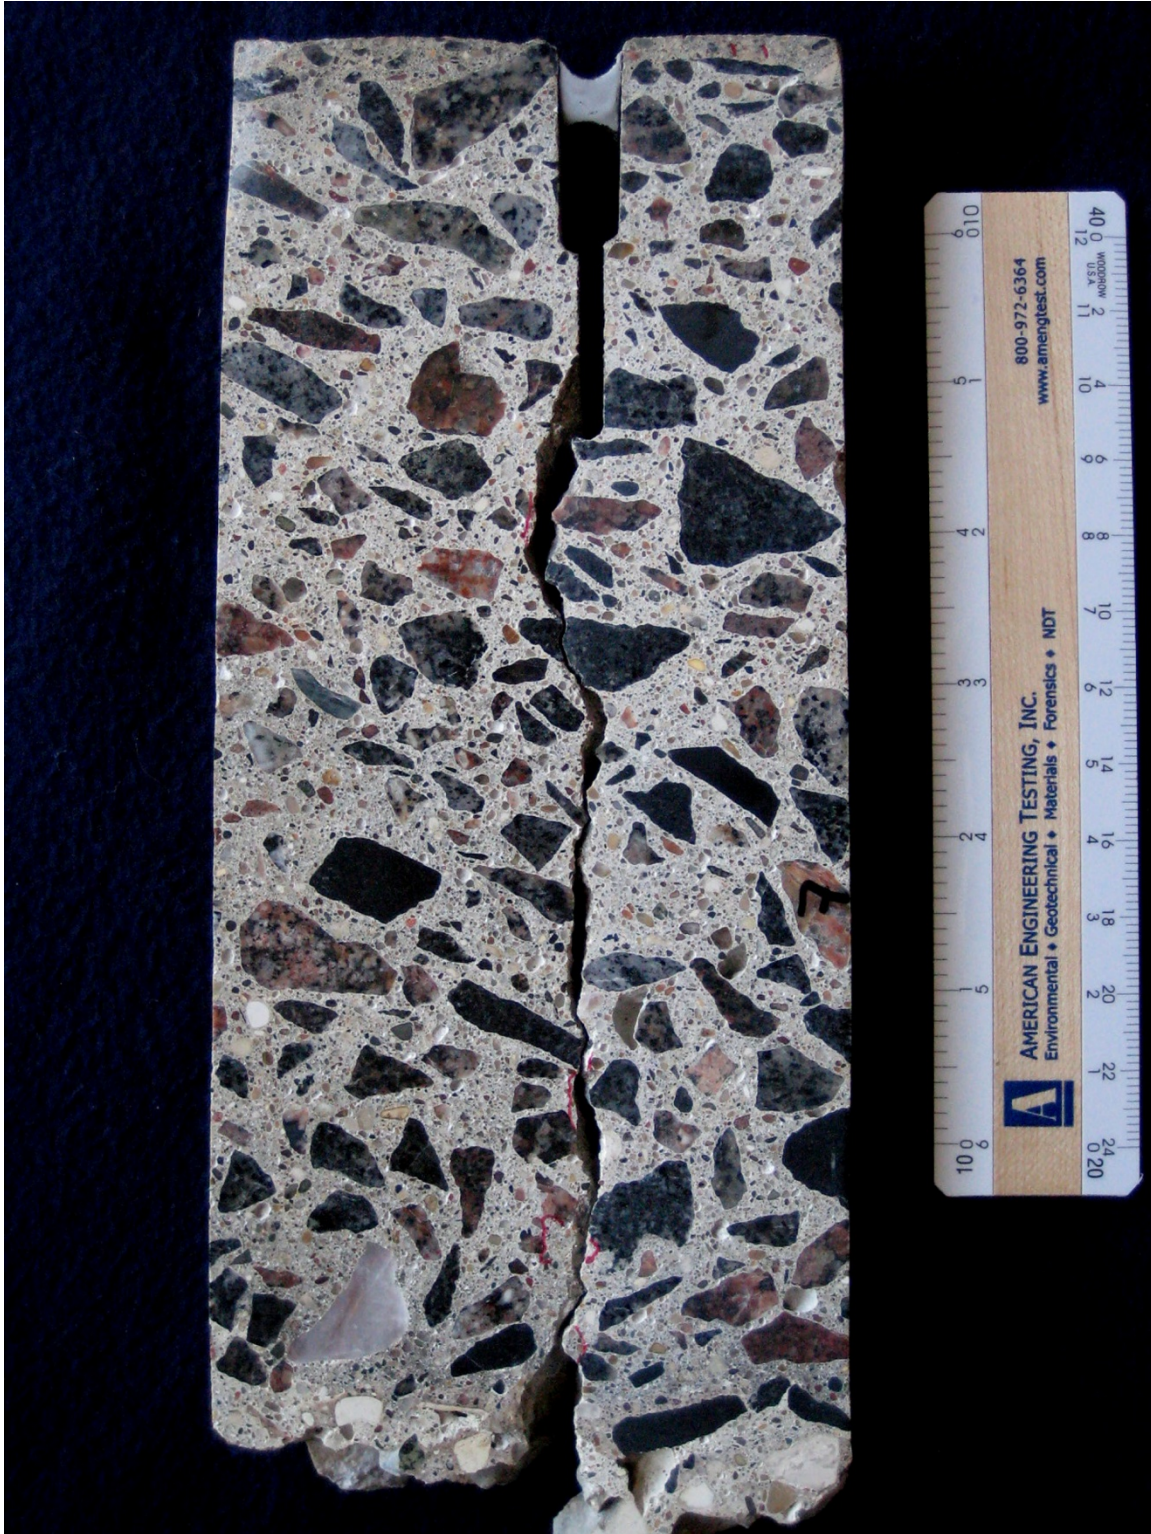
PHOTO: 10

SAMPLE ID: 7, 4705-30 **DESCRIPTION:** Sawcut and lapped cross section of core. Some fine sub-vertically oriented microcracks along the joint crack are mapped in red ink.

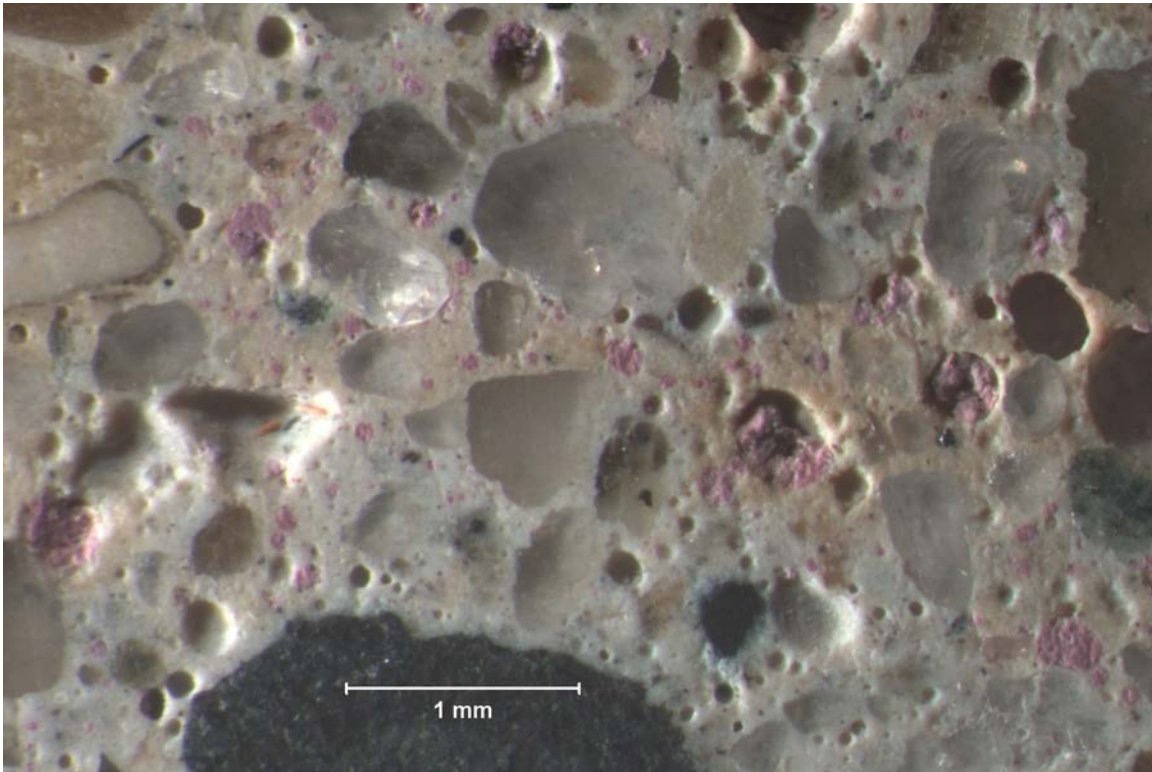
PHOTO: 31

SAMPLE ID: 4, 4705-30 **DESCRIPTION:** Magenta-stained ettringite fills many fine air voidspace in the paste at 20mm from the distressed joint plane at 155mm depth in the core.

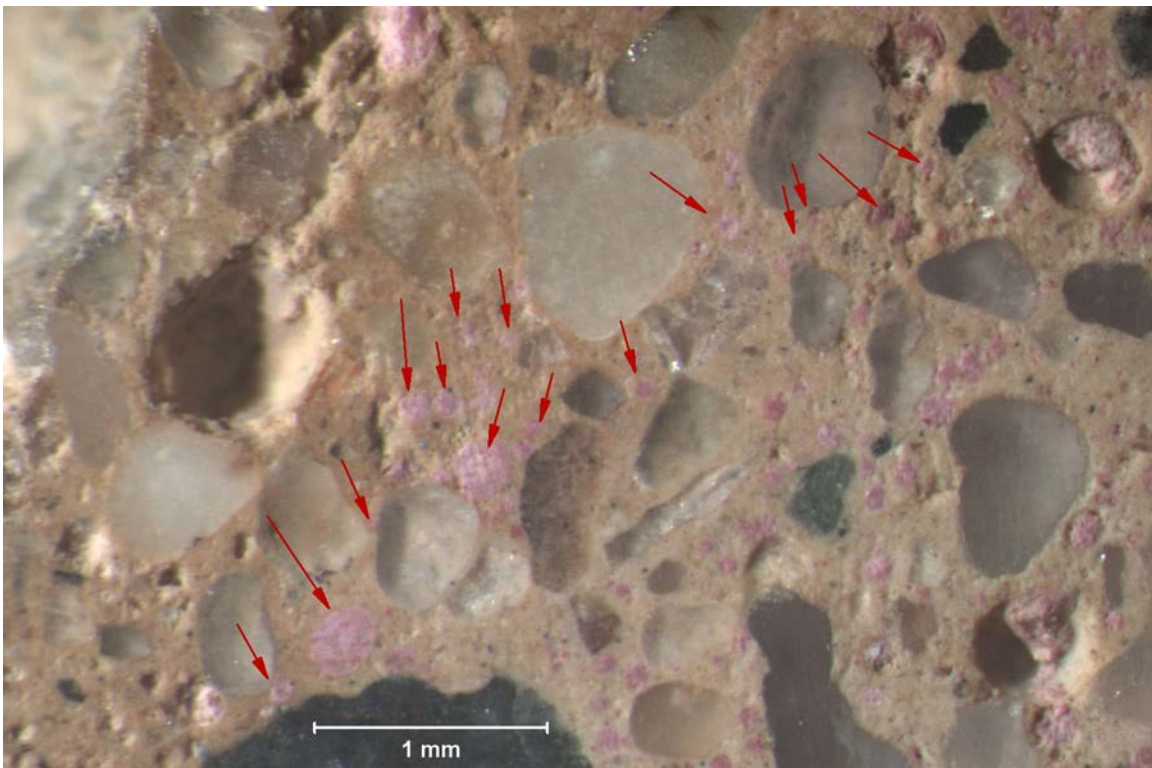
PHOTO: 32

SAMPLE ID: 4, 4705-30 **DESCRIPTION:** Magenta-stained ettringite fills most fine air voidspace in the paste directly adjacent to the distressed joint plane at 140mm depth in the core.

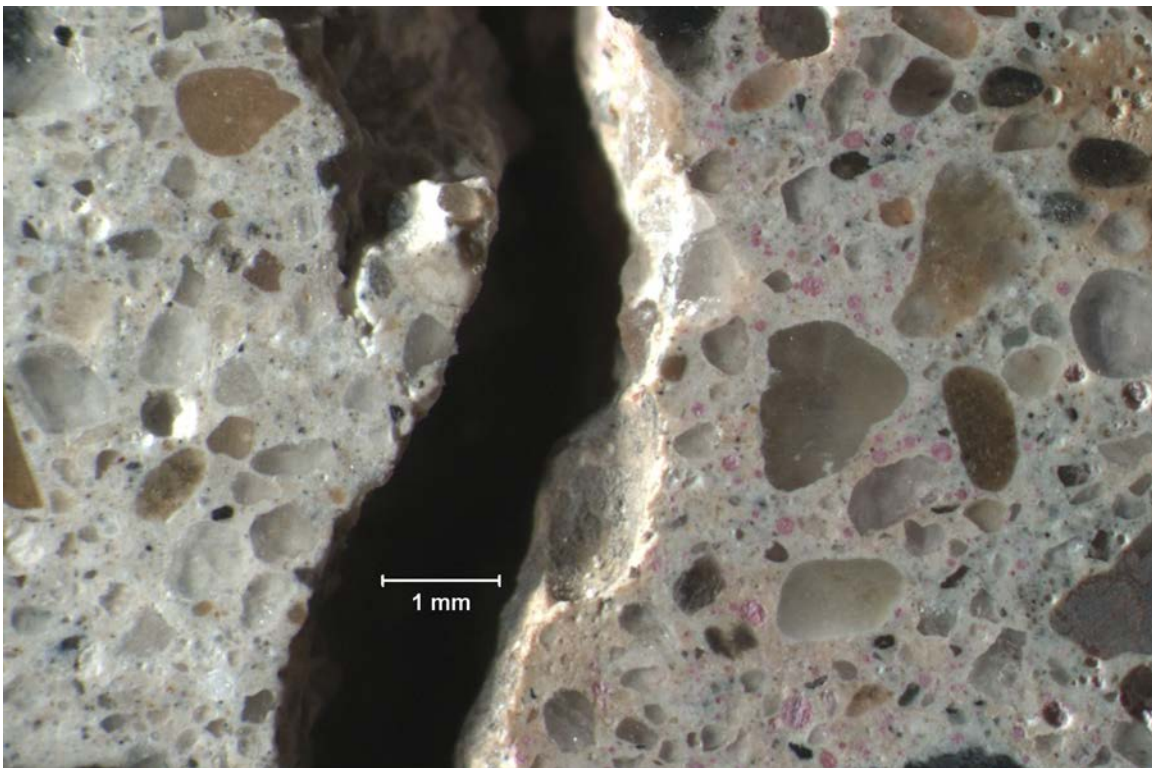
PHOTO: 34

SAMPLE ID: 7, 4705-30 **DESCRIPTION:** Magenta-stained ettringite (right side) and unstained ettringite (left) fills most fine air void-spaces in the paste directly adjacent to the mildly distressed joint plane at 130+mm depth in the core.
MAG: 15x

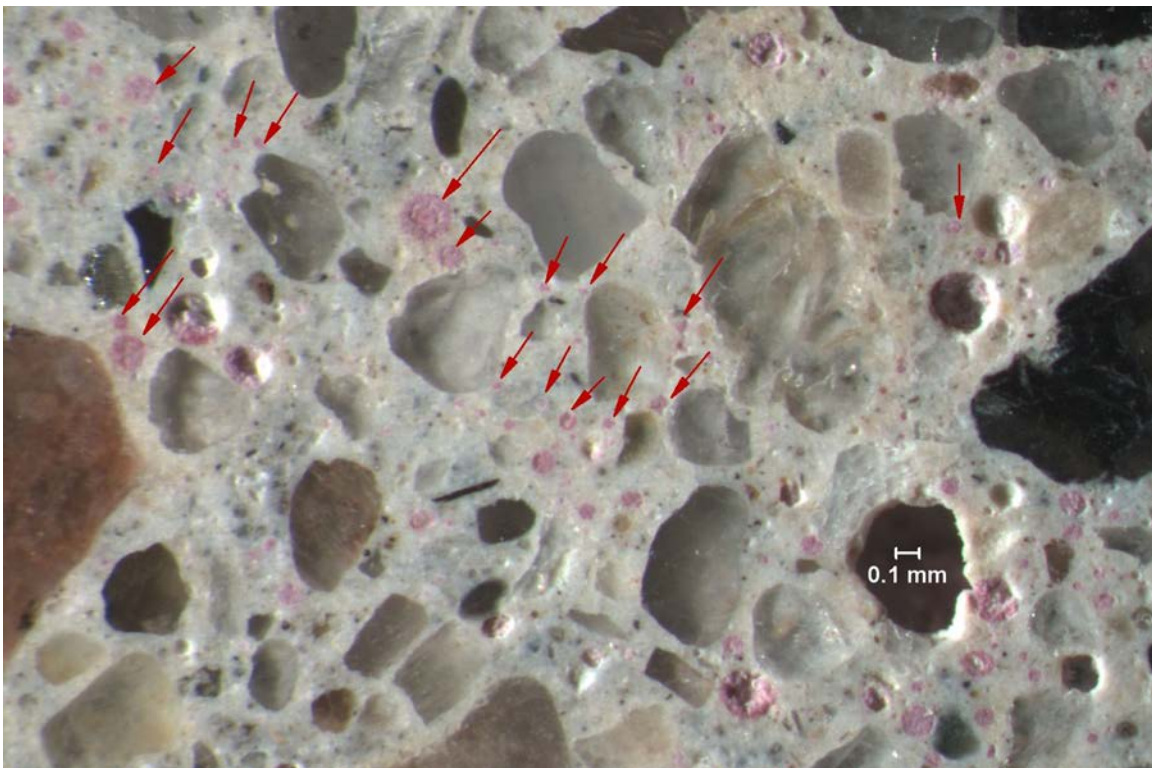
PHOTO: 36

SAMPLE ID: 7, 4705-30 **DESCRIPTION:** Magenta-stained ettringite fills most fine air voidspaces in the paste at 120mm depth in the core and within 8mm of the mildly distressed joint plane.

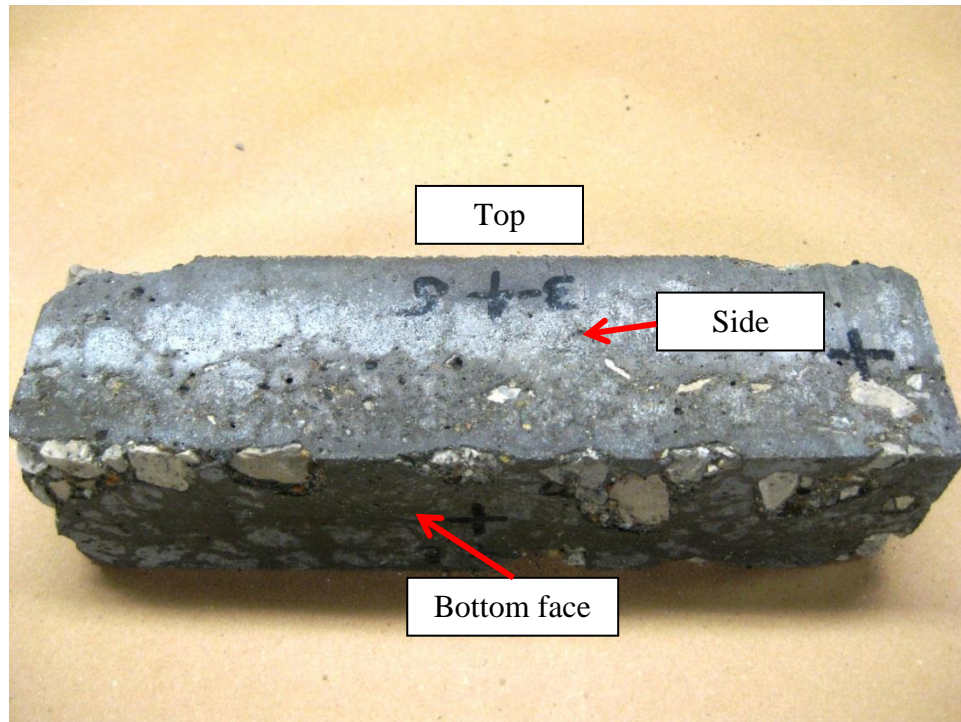
Figure 4. Typical sample after 300 cycles

The visual rating shows, as expected, that the wet portion of the samples have more distress than the dry portion and the bottom side of the samples have the most distress (Figure 4).

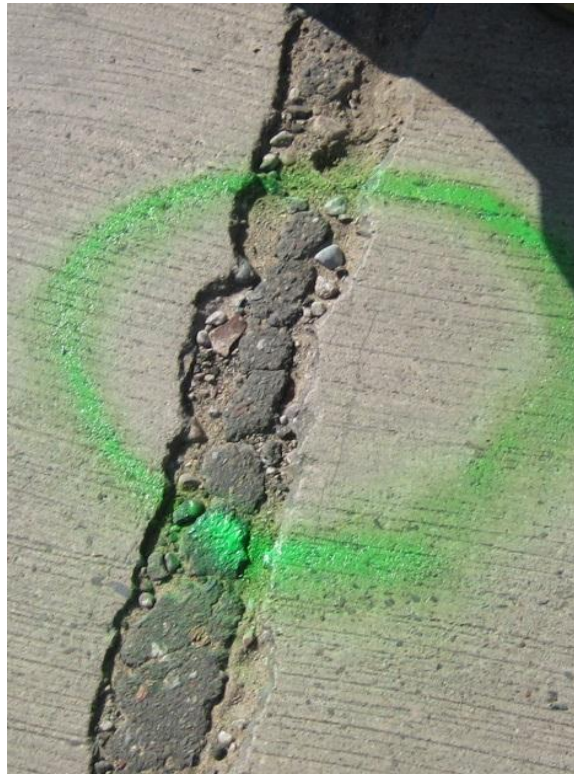
Figure 1. Crack formed about 1 in. from the free surface

It is not uncommon to observe a crack about 1 in. from the joint face (Figure 1).

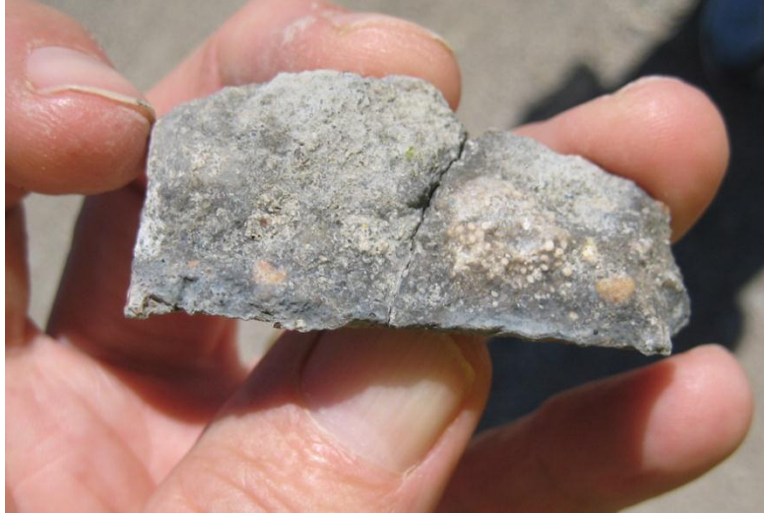
Figure 2. Sample removed piece showing that material between the free surface and the new crack is reasonably sound with coarse aggregate particles free of paste

In some cases, the concrete in between is in good condition (Figure 2).

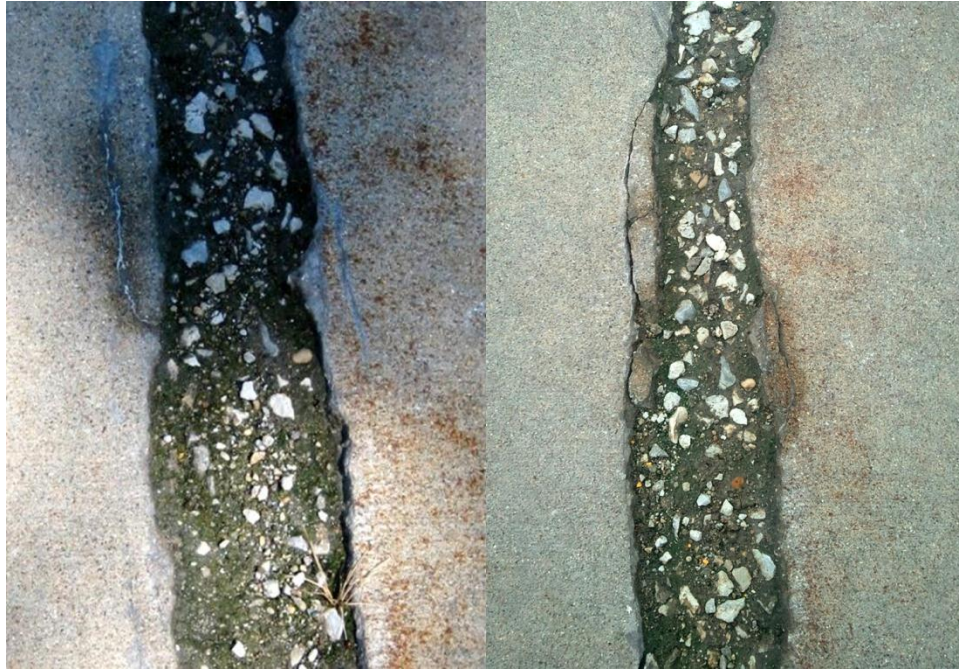
Figure 4. Sample of damage increasing over time (July 2011 to July 2012)

Over time, the crack will widen until the wedge is loosened and removed by traffic (Figure 4). The aim of this work was to investigate the feasibility of this hypothesis.
